STANDING BUILDING SURVEY

SAIGHTON CAMP

CHESTER

ARCHAEOLOGICAL STANDING BUILDING SURVEY

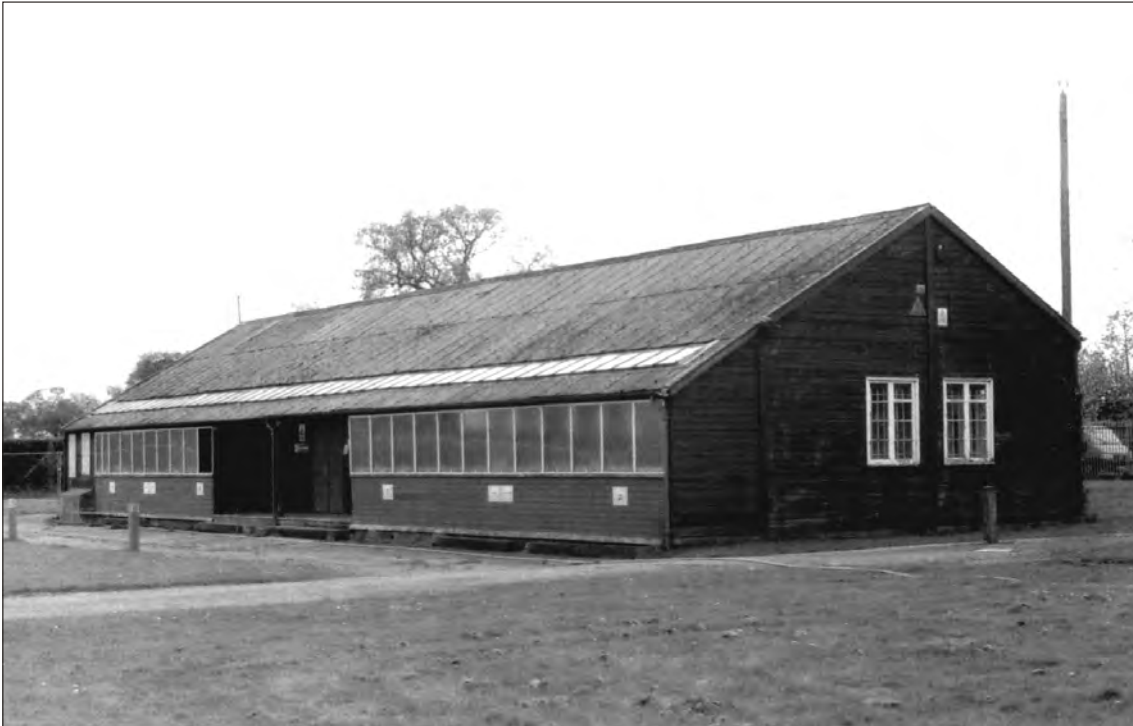
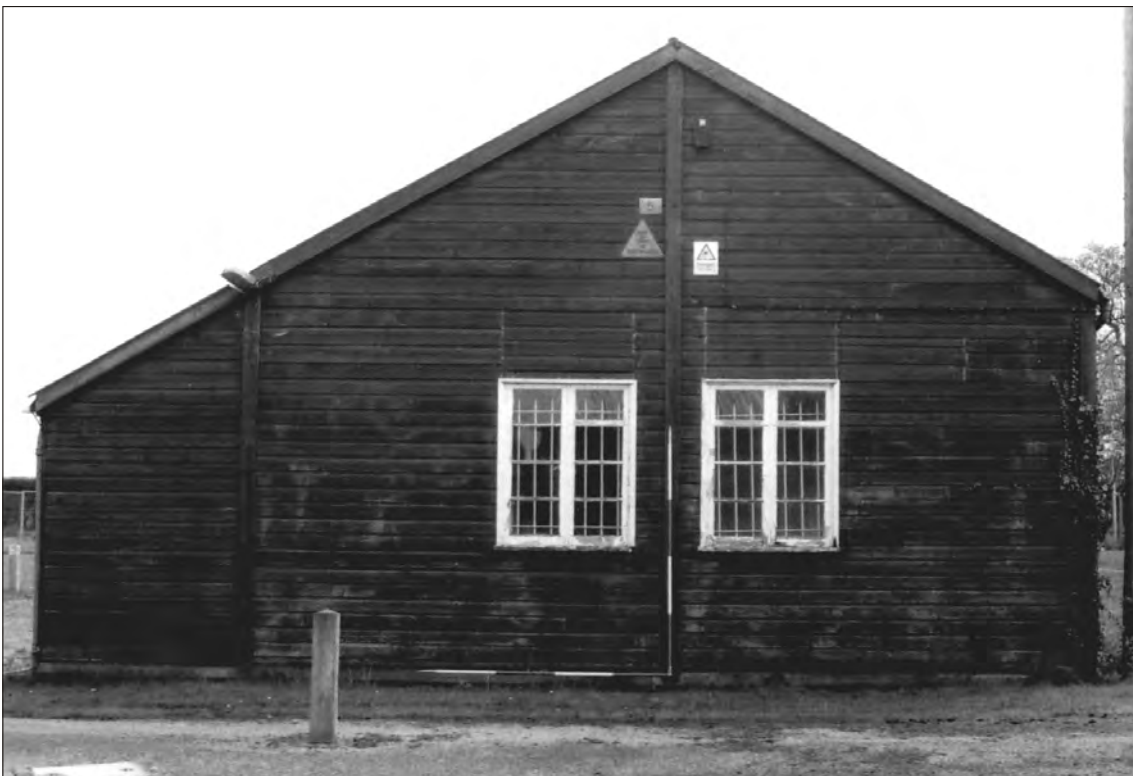
- 5.25 Building 5 is in a relatively good state of repair as it has been maintained for current use by the camp security guard and as a meeting room for police training courses. However, there is some superficial damage to the building, which is evident from the outside and through limited inspection of the interior. The external timber panelling is bowing and rotting on all faces of the building except the veranda, which appears to have been installed later. The suspended wooden floors are also rotting and are unsafe to walk on in places. The cast iron guttering is corroded and leaking although the inside of the building appears to be watertight.

The wooden window frames are in a particularly bad condition and three of the windows have been boarded up.

Plate 5 Saighton Camp, Chester: north and east facing elevations of building 5

Plate 6 Saighton Camp, Chester: north facing elevation of building 5

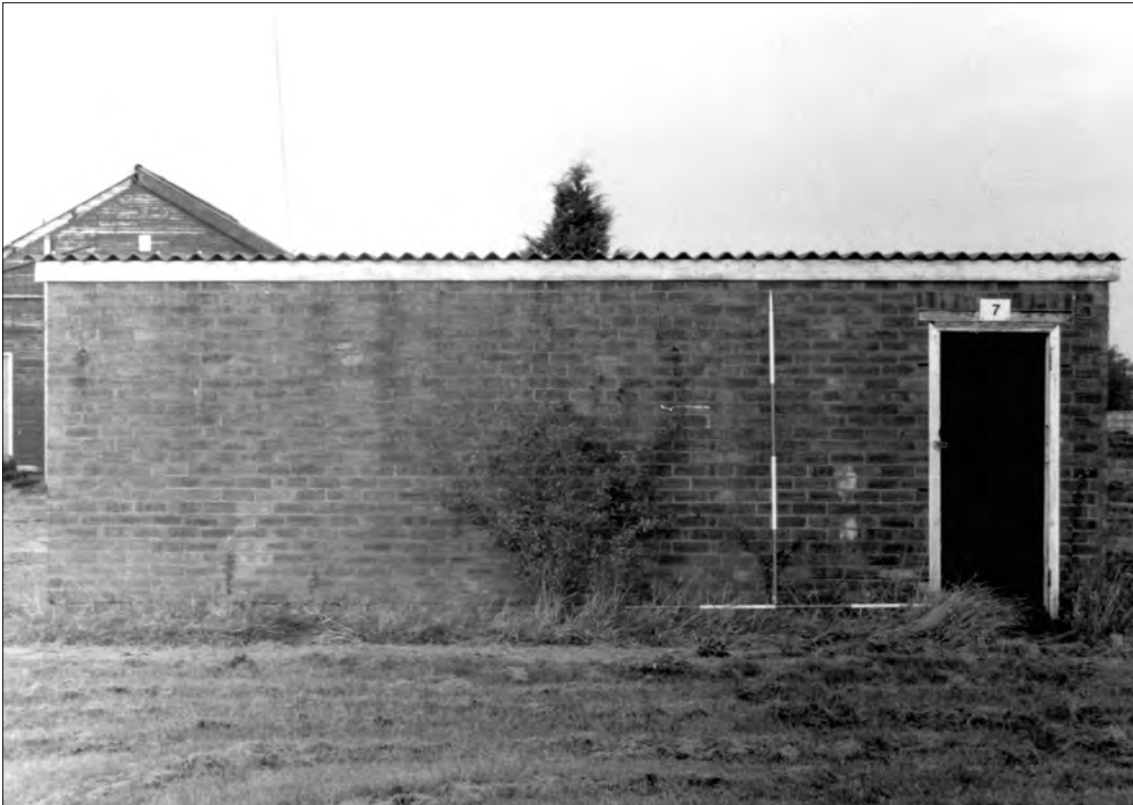
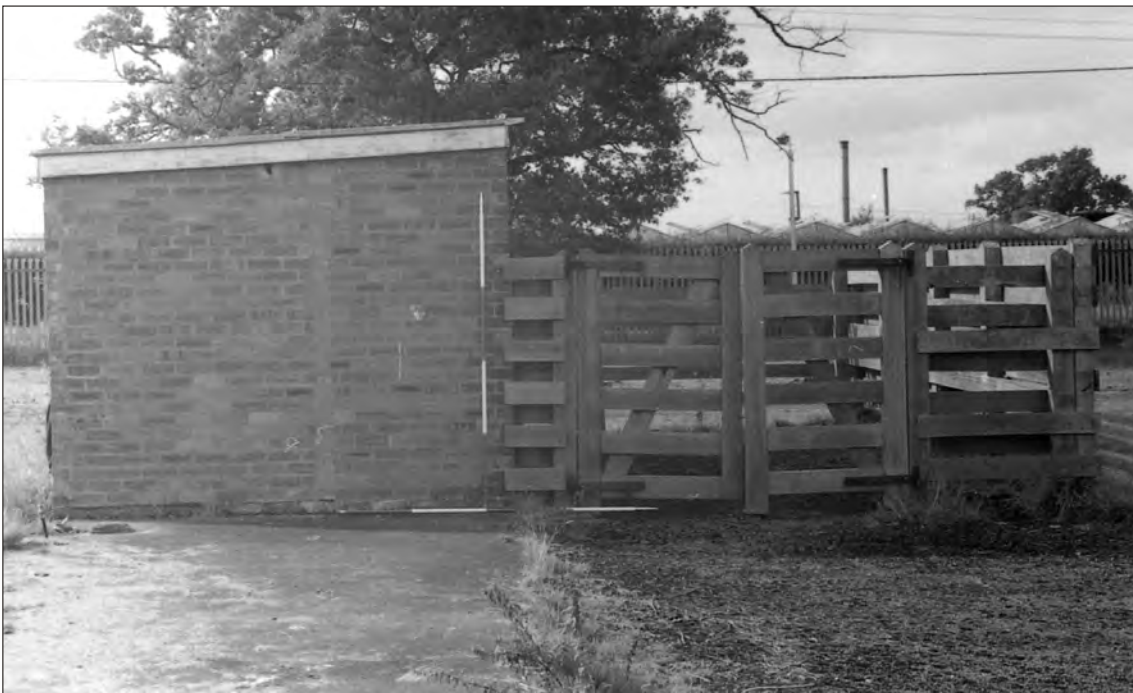
- 5.32 Building 7 is generally in a good state of repair and it appears that it has been re-roofed recently.

Plate 7 Saighton Camp, Chester: south facing elevation of building 7

Plate 8 Saighton Camp, Chester: east facing elevation of building 7

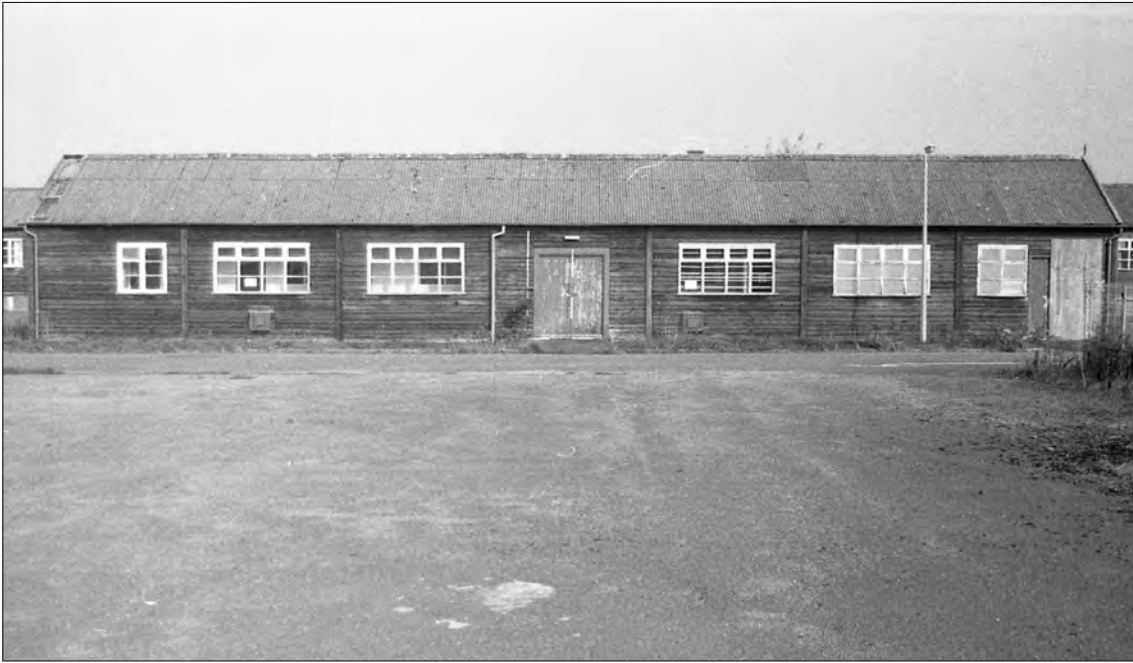
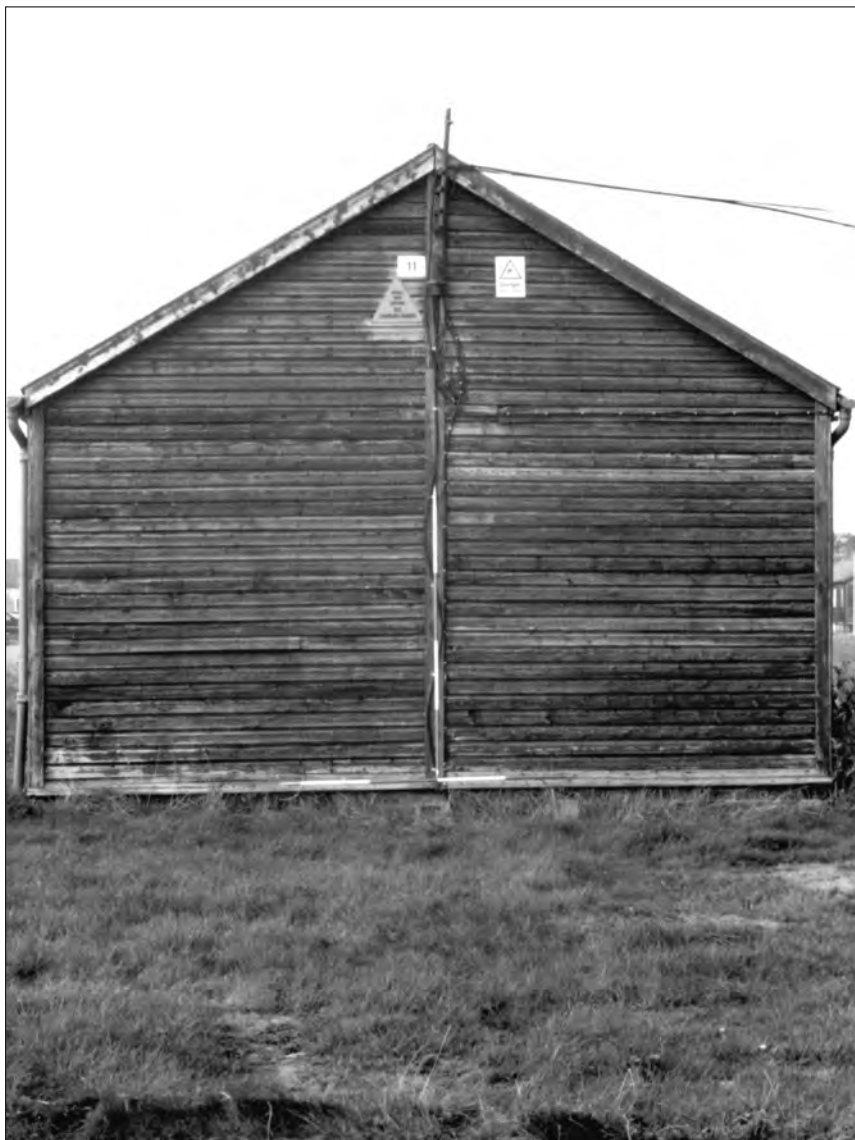
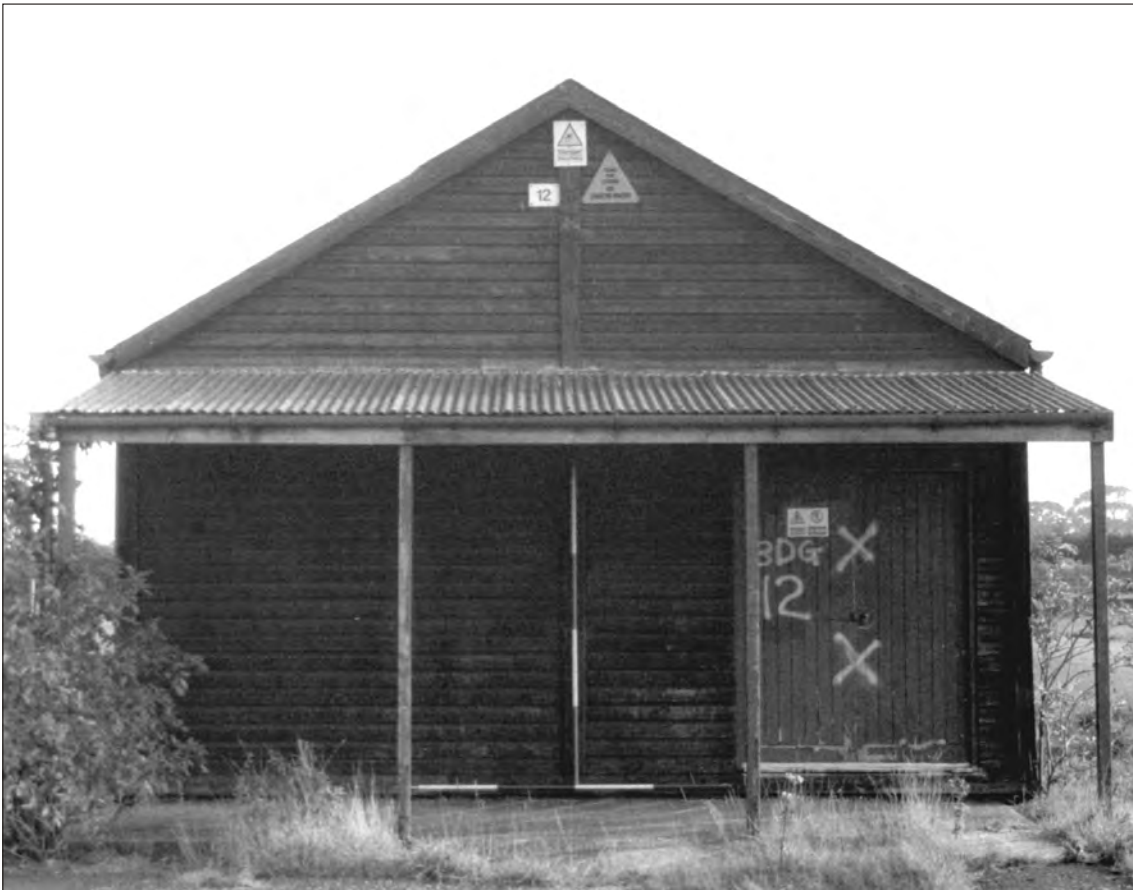
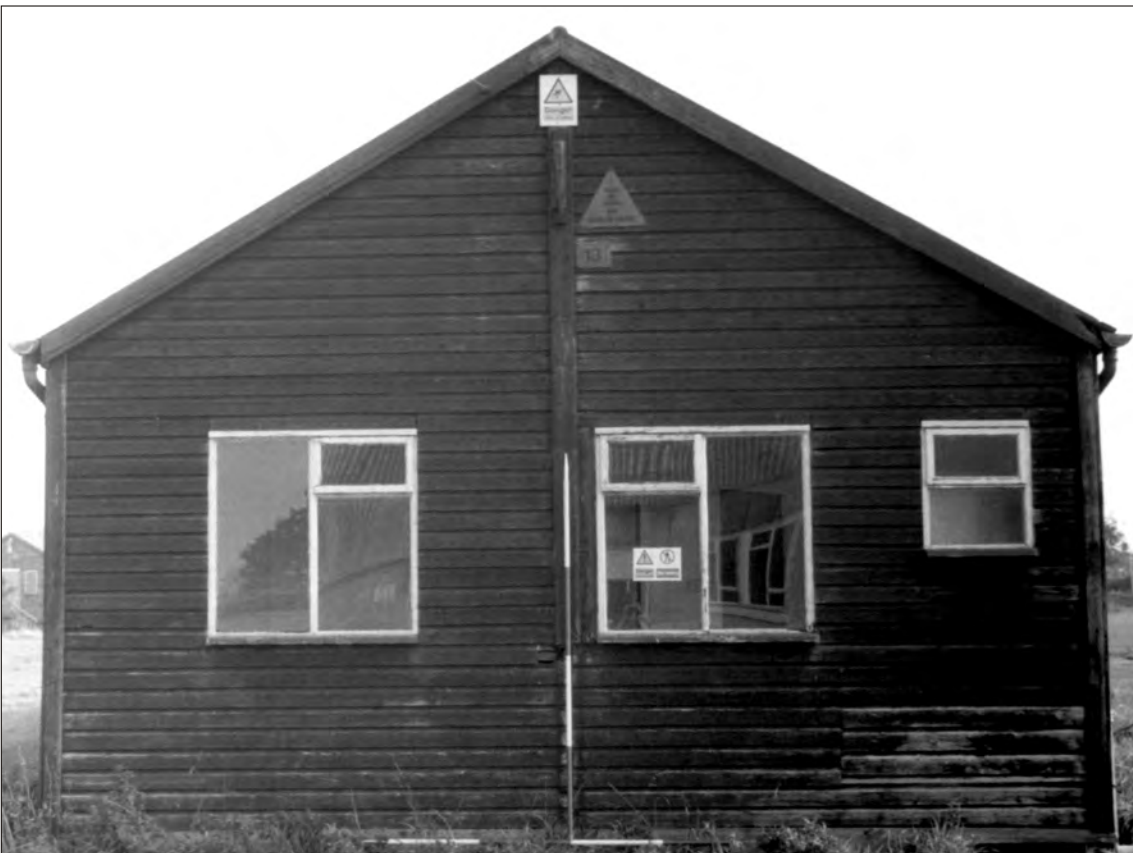
- 5.45 The exterior timber cladding of this group of buildings is in reasonable condition, having been regularly maintained until relatively recently. Internally the building is in poor condition, having suffered from general dilapidation. The roofs of the structures appear largely watertight but the suspended timber floor in Building 12 is rotten, and similar conditions can be expected in Buildings 11 and 13.

Plate 9 Saighton Camp, Chester: west facing elevation of building 11

Plate 10 Saighton Camp, Chester: south facing elevation of building 11

Plate 11 Saighton Camp, Chester: north facing elevation of building 12

Plate 12 Saighton Camp, Chester: north facing elevation of building 13

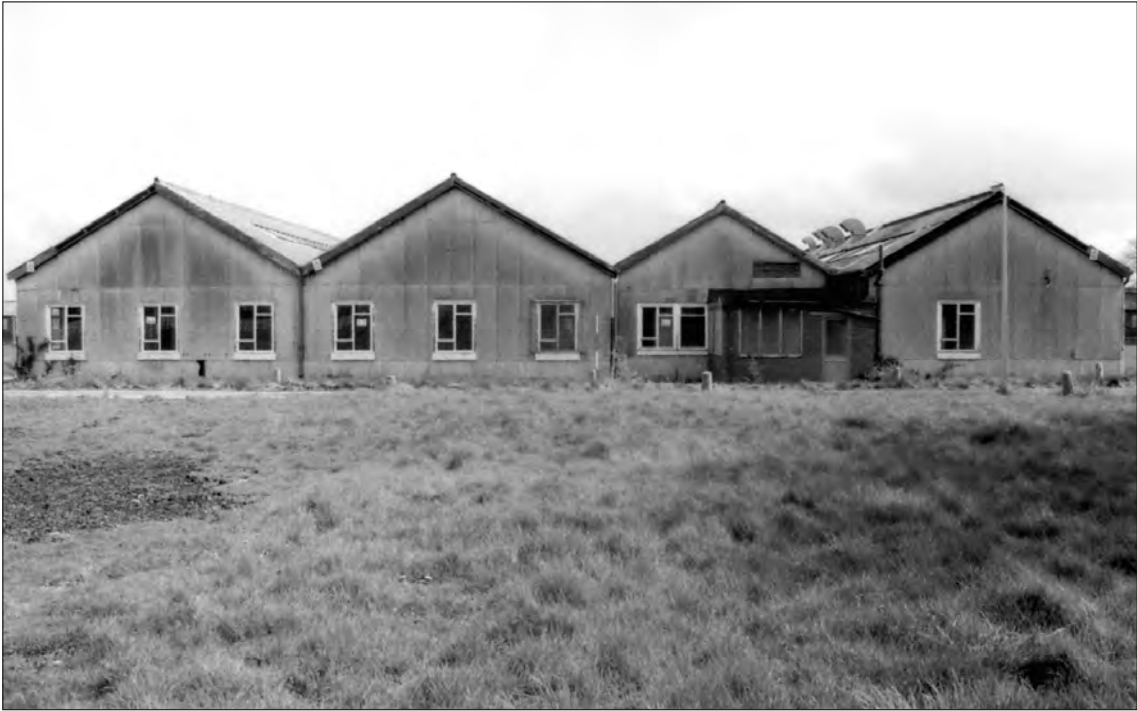
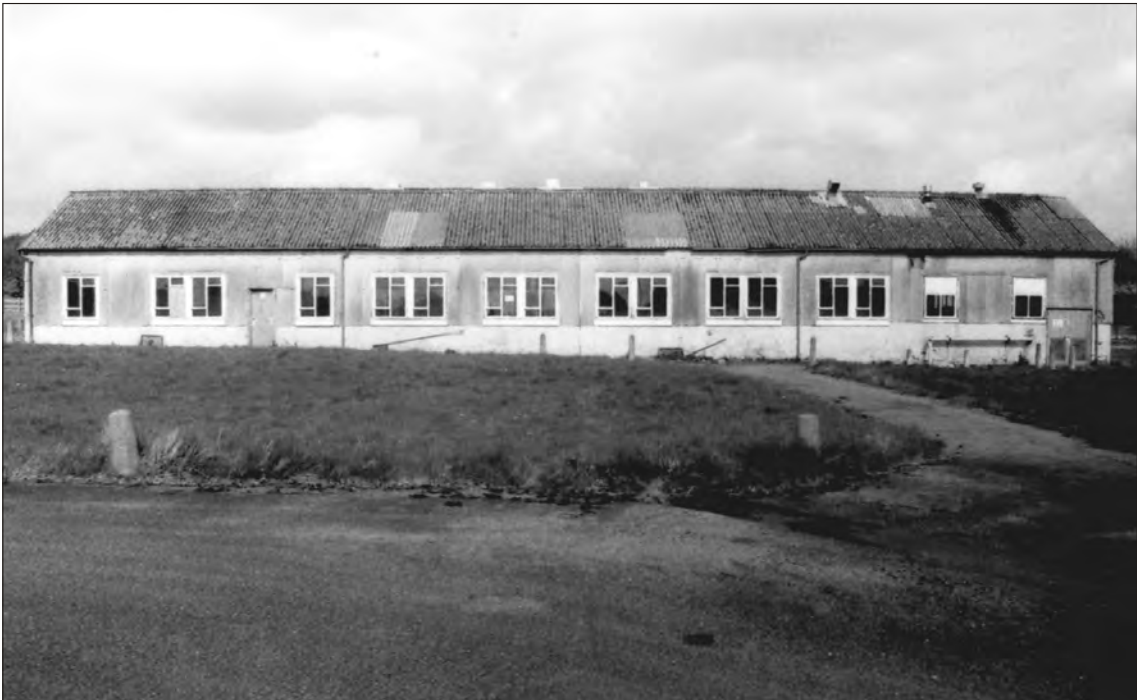
- 5.56 Building 15 is in a poor state of repair. The iron framework is severely corroded where it meets the concrete, which potentially undermines the structure of the building and the cast iron guttering is similarly rotten. The asbestos cladding and fibreboard panels are coming away from both the roof and the walls and are prone to leaking. The floor surface is uneven and the tiles are disturbed throughout. The timber doors and wooden window frames are also rotten in places.

Plate 13 Saighton Camp, Chester: west facing elevation of building 15

Plate 14 Saighton Camp, Chester: south facing elevation of building 15

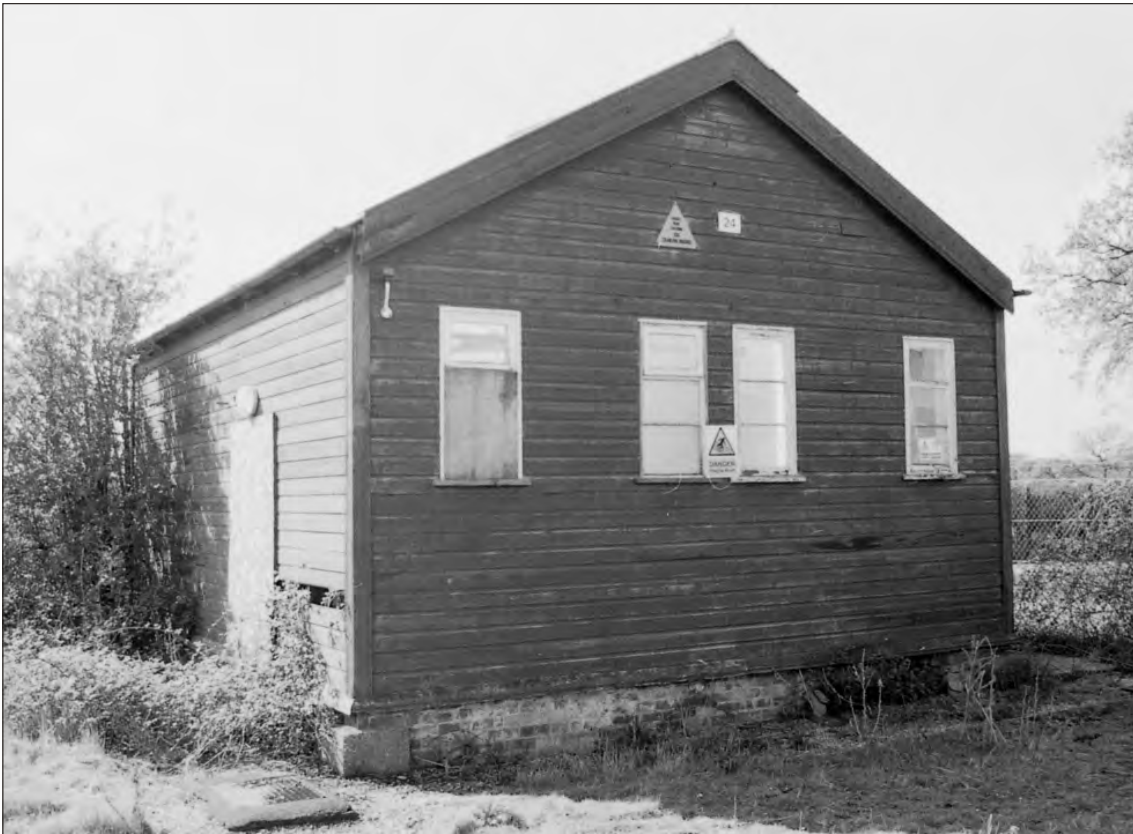
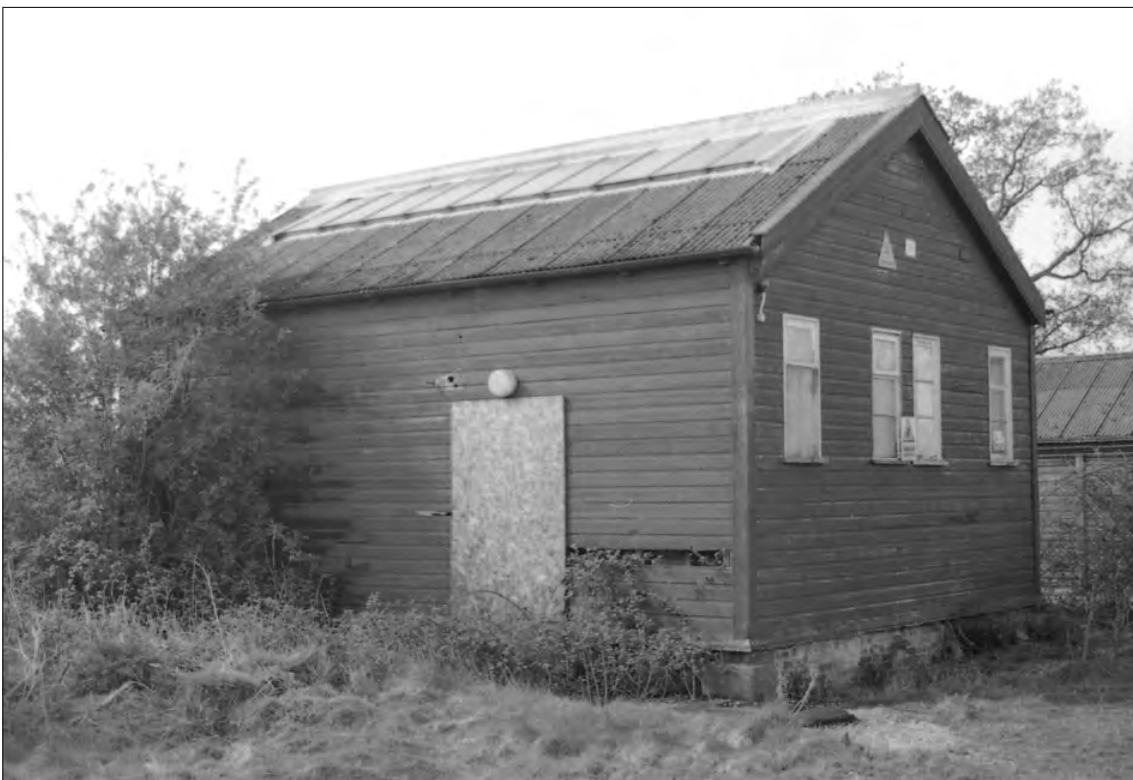
- 5.75 The roof of Building 24 was in reasonable condition having been replaced relatively recently and the timber cladding was generally in a good state of repair, apart from one timber panel, which had come away from the eastern elevation. The doors had been boarded-up so were presumably in a poor condition and the window frames were rotten in all cases. It was impossible to access the interior of the building, but it was evident that the pipes to the toilets and sinks had been leaking and no attempt had been made to repair them.

Plate 19 Saighton Camp, Chester: north facing elevation of building 24

Plate 20 Saighton Camp, Chester: east facing elevation of building 24

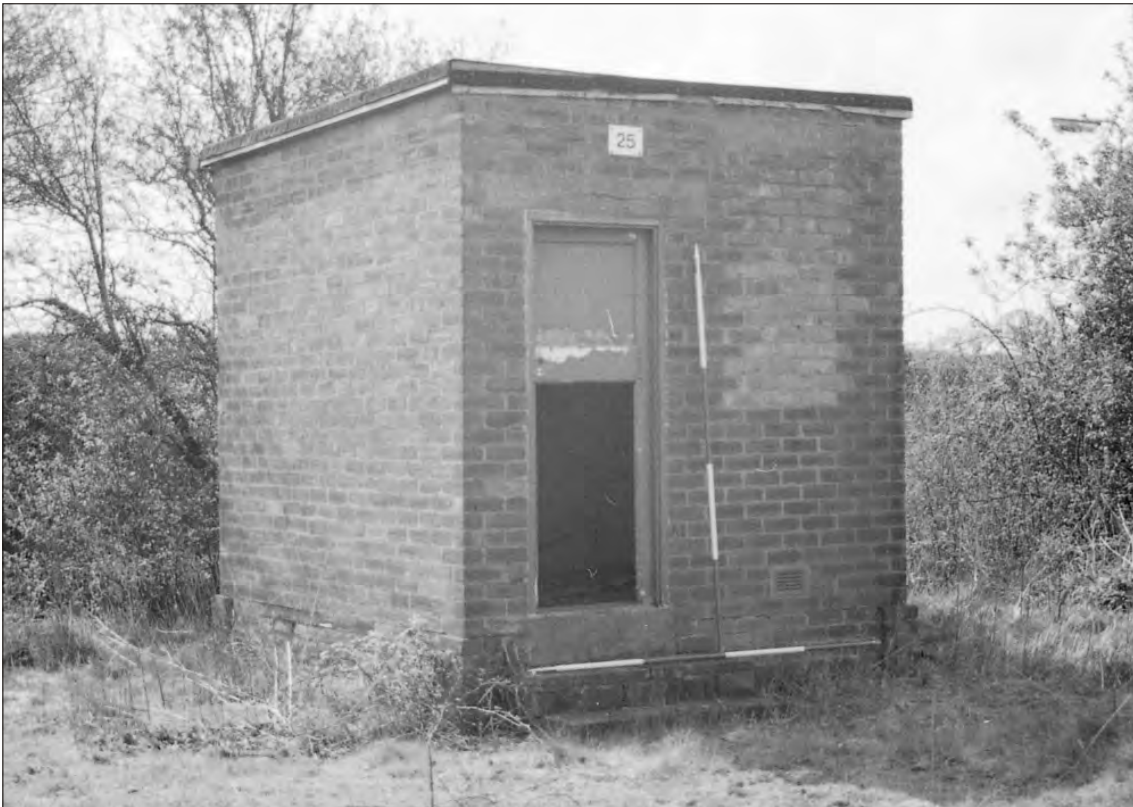
- 5.85 The interior of Building 25 is in a poor condition as the roofing felt is leaking. The lowest five courses of brickwork located below the damp-proof coursing are rotting and the concrete lintel over the doorway has split. The timber door has also been badly damaged.

Plate 21 Saighton Camp, Chester: north and west facing elevations of building 25

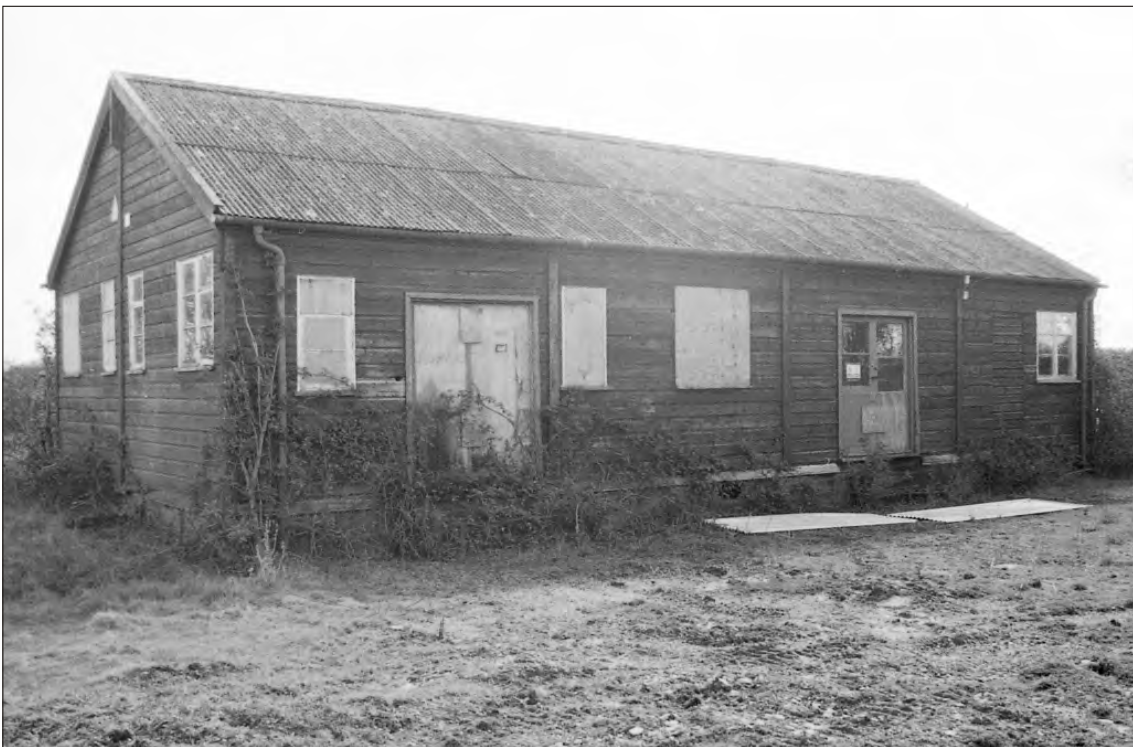
- 5.93 The overall condition of Building 26 is poor. A number of the asbestos roof panels have been displaced which would make it prone to leaking. Some of the bricks are missing from the foundation of the building which is probably due to dampness and the exterior wood panelling is rotting. The majority of the doors and windows have been covered with fibreboard and have probably been damaged as a result of police training exercises in this sector of the camp.

Plate 22 Saighton Camp, Chester: north and west facing elevations of building 26

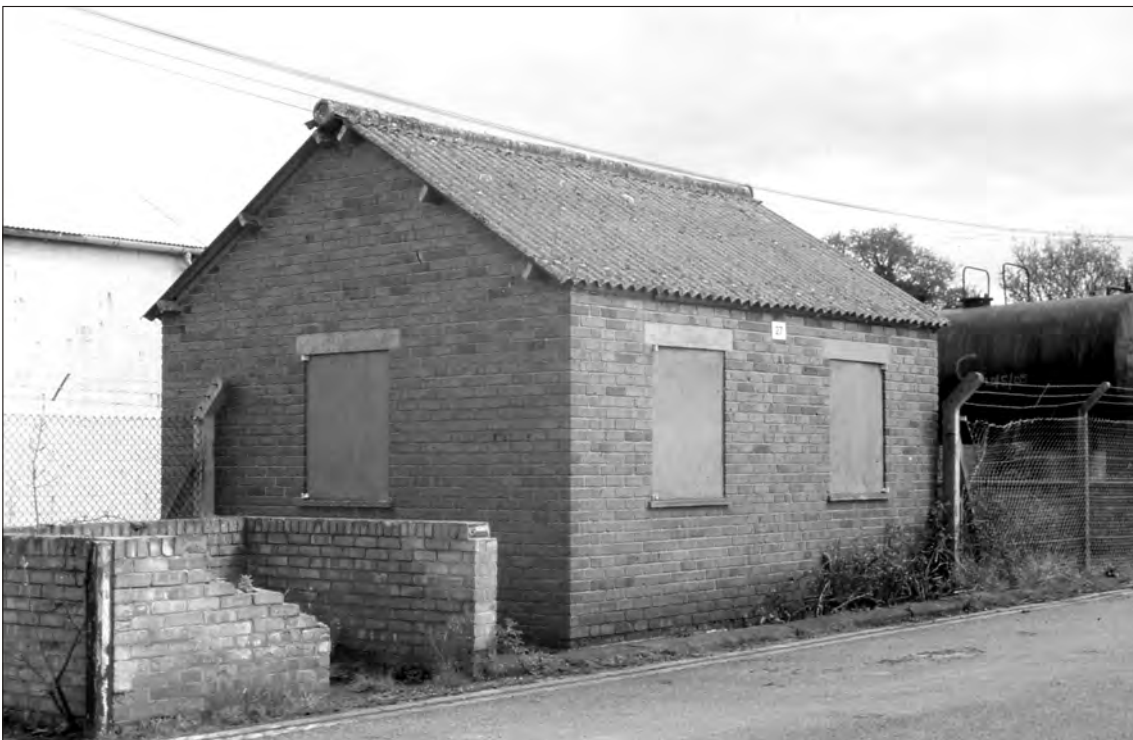
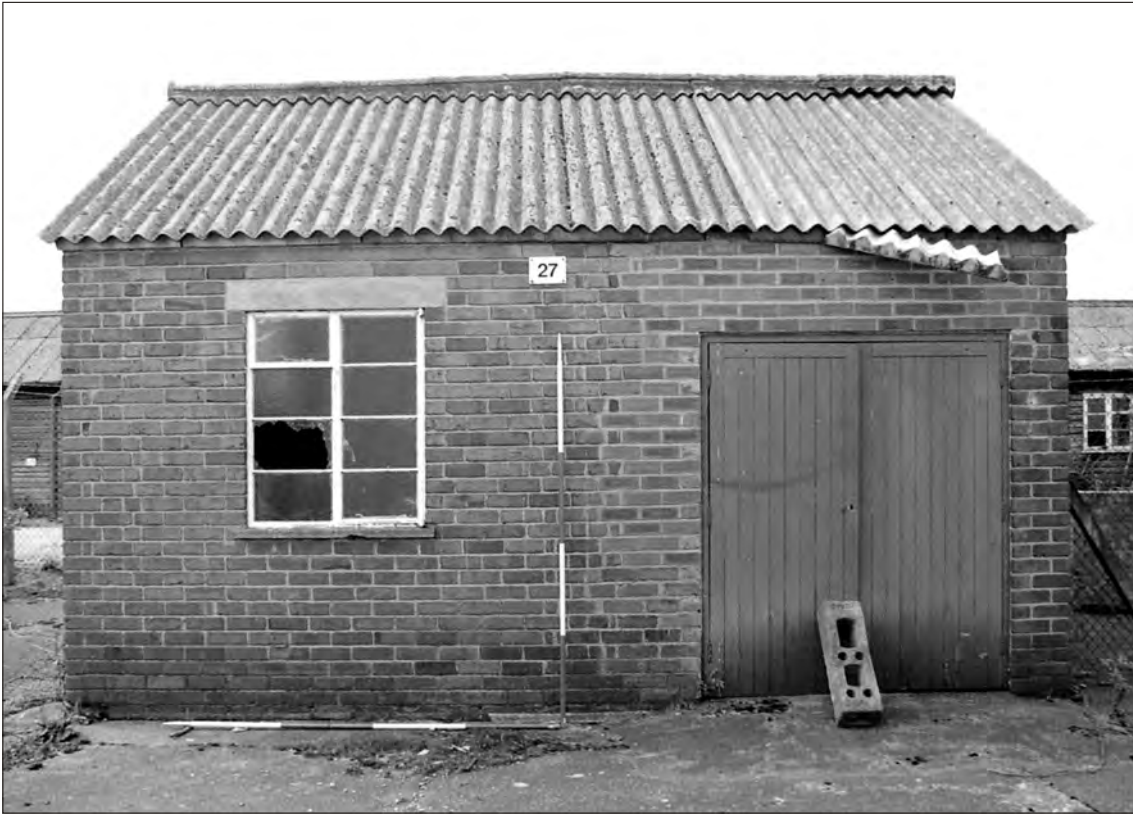
- 5.101 Building 27 is in a relatively good state of repair and appears to have been well maintained. One of the windows has been broken which could possibly be attributed to recent police training exercises in this area. The paint on the woodwork is peeling slightly but otherwise it is in good condition.

Plate 24 Saighton Camp, Chester: north and west facing elevations of building 27

Plate 25 Saughton Camp, Chester: east facing elevation of building 27

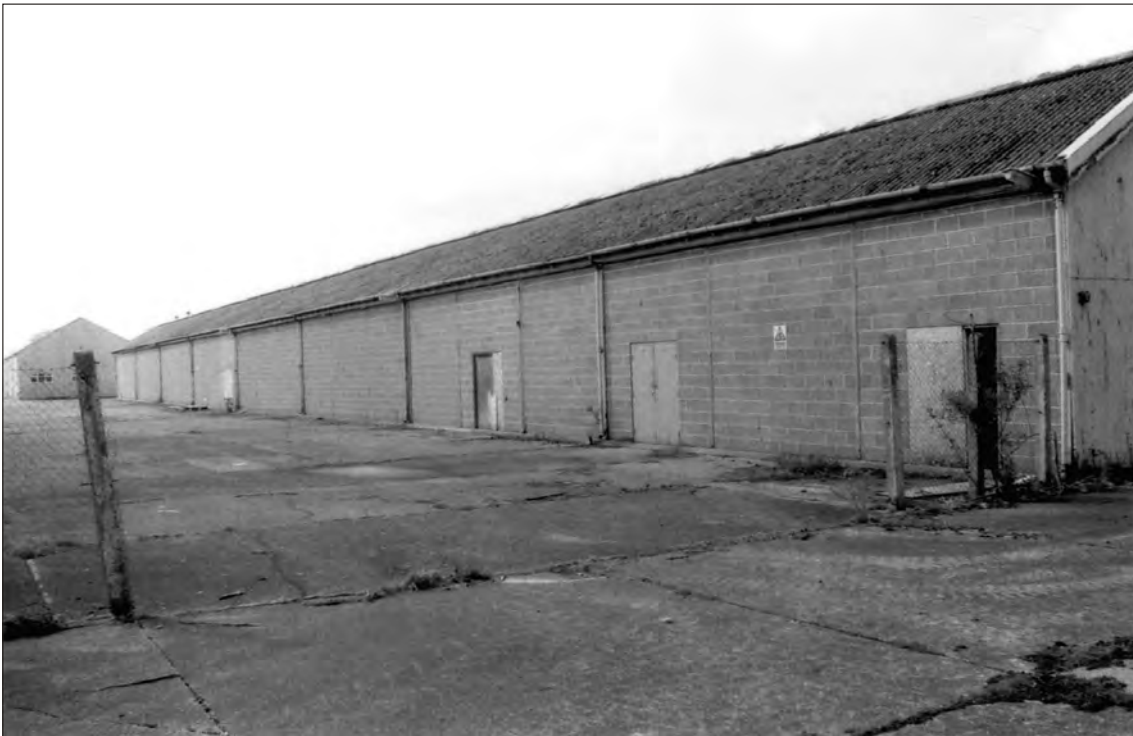
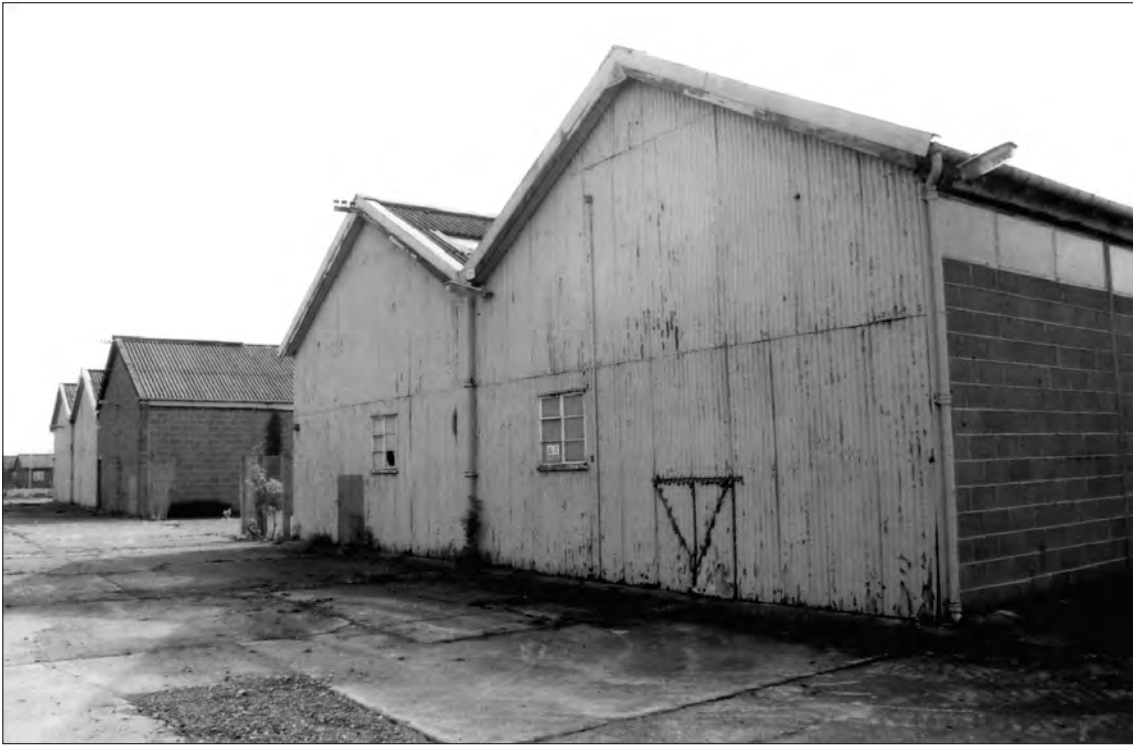
- 5.122 The framework of Building 29 is in a poor state of repair as the iron columns are corroded where they are set into concrete. The corrugated iron cladding on the northern and eastern elevations is also rotting towards the base and one of the windows in the northern elevation has a broken pane of glass, possibly resulting from police training activities in this sector of the camp. It was impossible to assess the condition of the interior of the building as access was restricted.

Plate 28 Saighton Camp, Chester: east facing elevation of building 29

Plate 29 Saighton Camp, Chester: north facing elevation of building 29

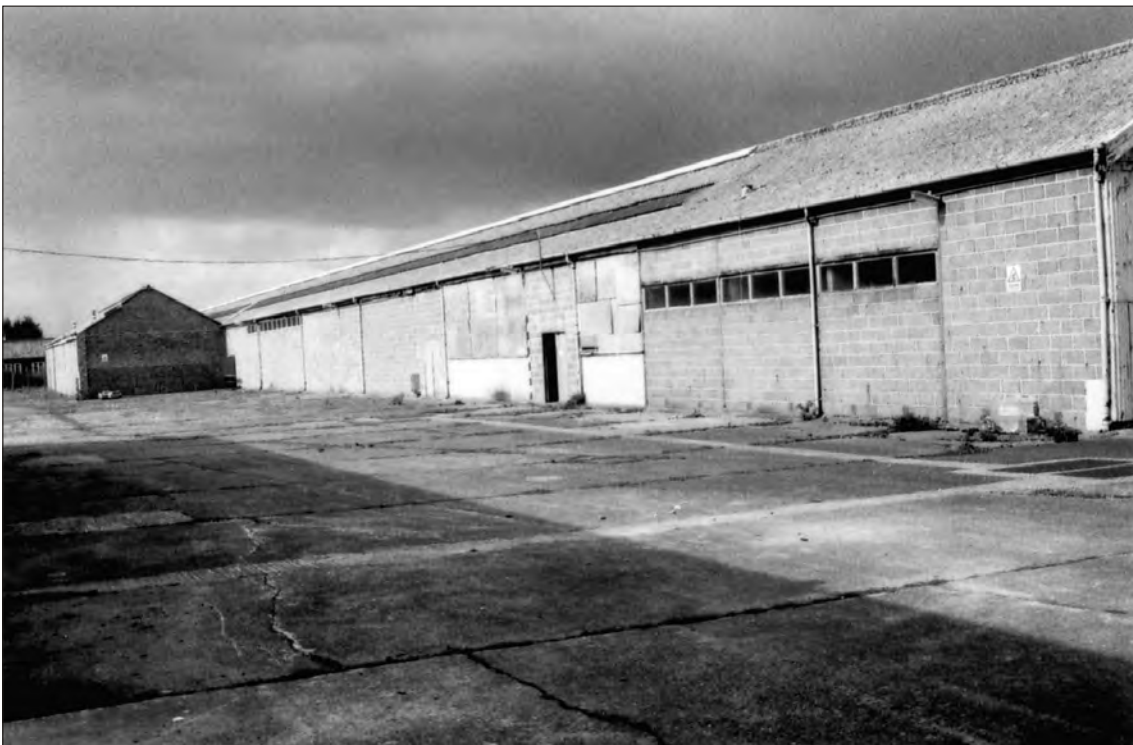
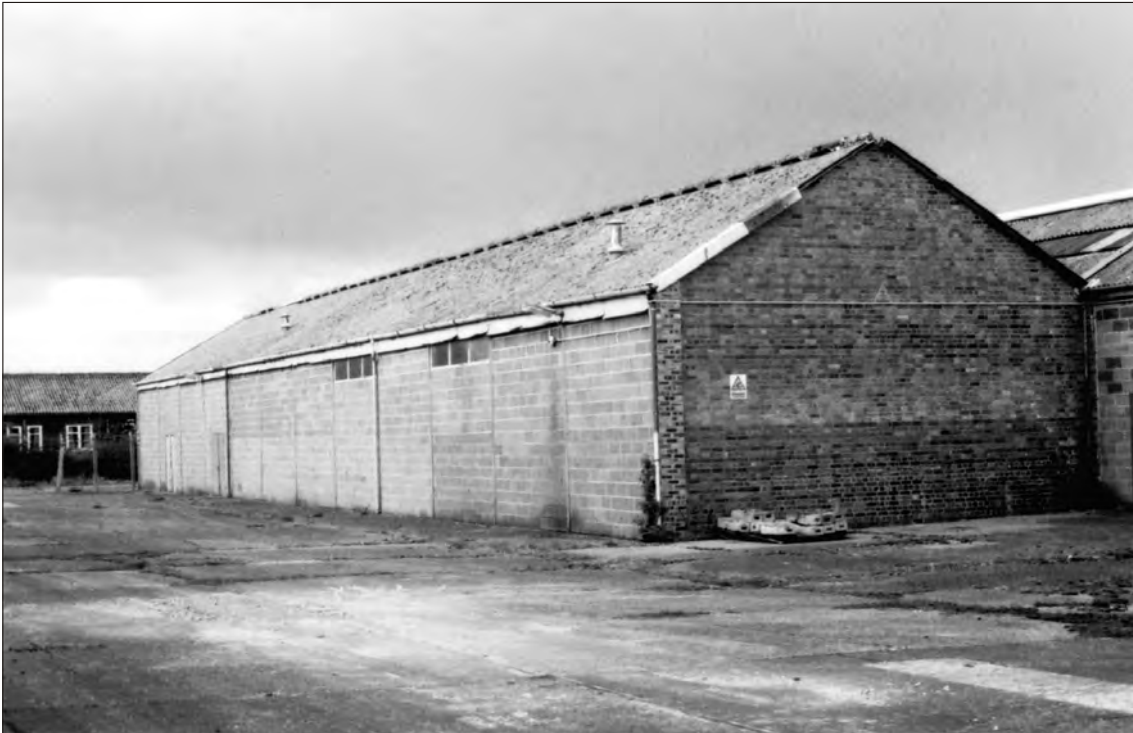
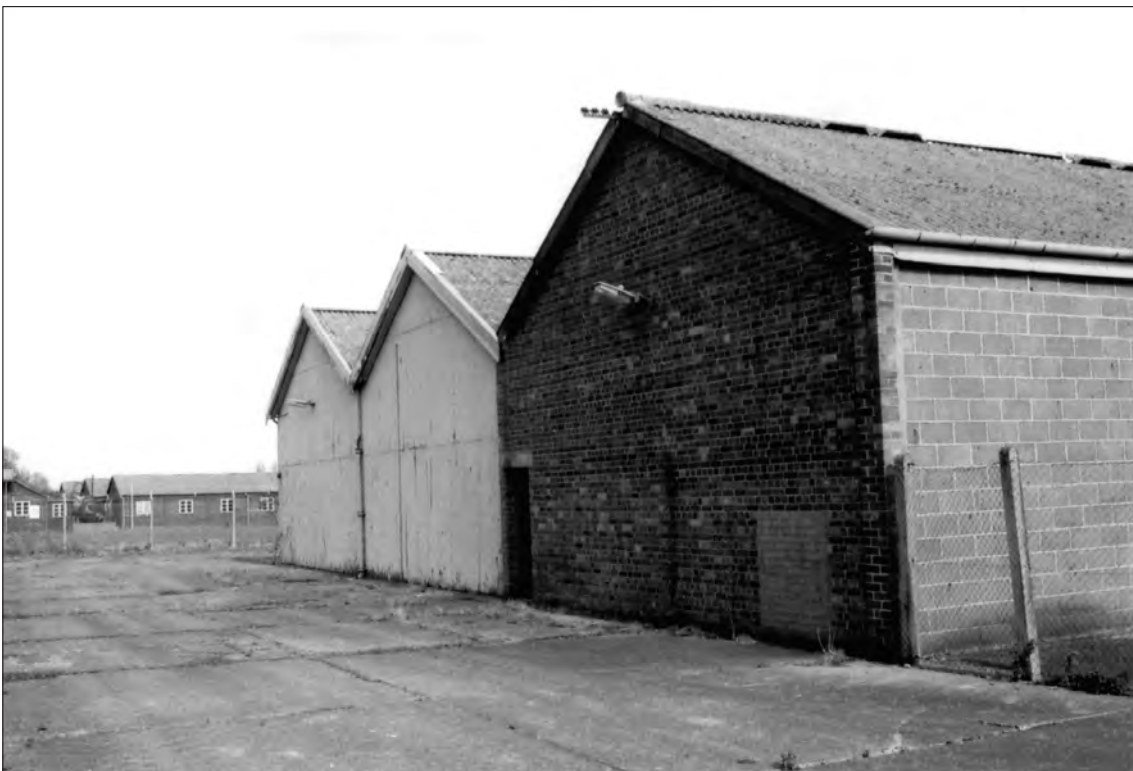
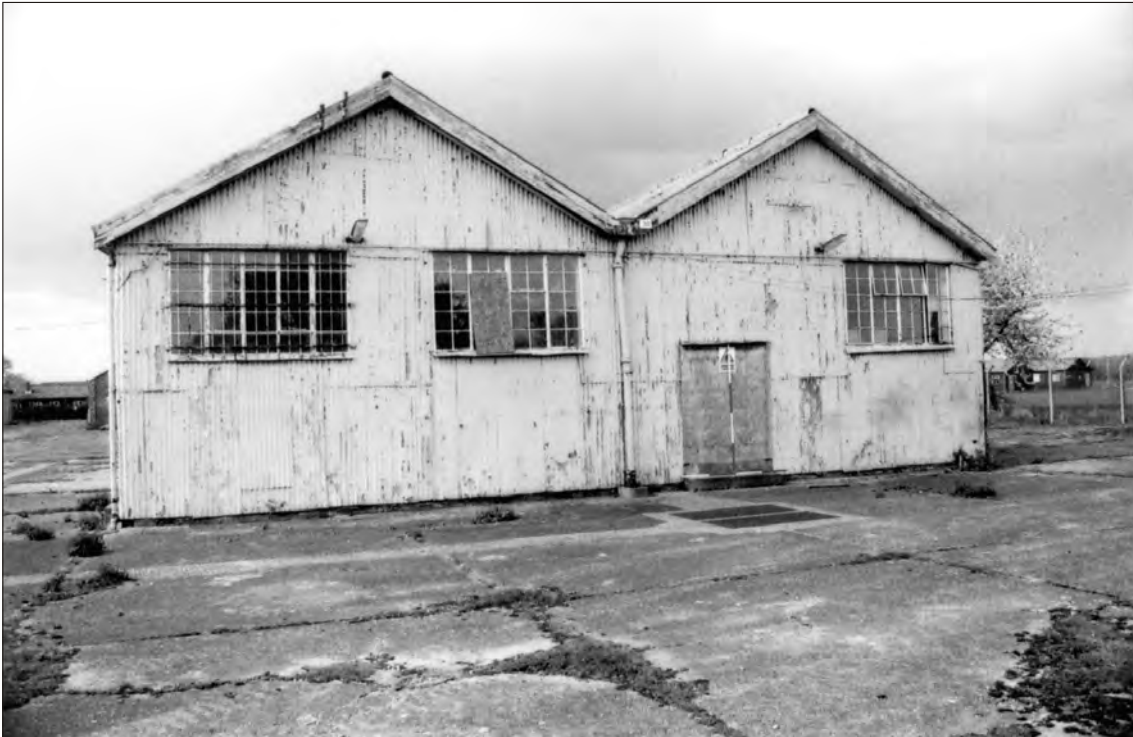
5.135 The supporting structure of Building 30 is in a poor state of repair as the iron columns are corroding towards the base where they are set into concrete. The southernmost four bays of the building, which display the most original features, are in a particularly poor condition. The suspended timber floor is rotten and unsafe to walk on in places and many of the acoustic ceiling tiles have been displaced, as is the case throughout the rest of the building. The casement windows in the southern sector show evidence of bullet-holes resulting from police training exercises and there is a certain amount of debris in this area probably resulting from the same activities. The original corrugated iron, which is cladding the exterior of the north and south elevations, is corroded and the asbestos roof panelling and valley guttering are similarly decayed resulting in leaking. The concrete floor is uneven and cracked in places.

Plate 30 Saighton Camp, Chester: west facing elevation of building 30

Plate 31 Saighton Camp, Chester: west facing elevation of western shed of building 30

Plate 32 Saighton Camp, Chester: north facing elevation of building 30

Plate 33 Saighton Camp, Chester: south facing elevation of building 30

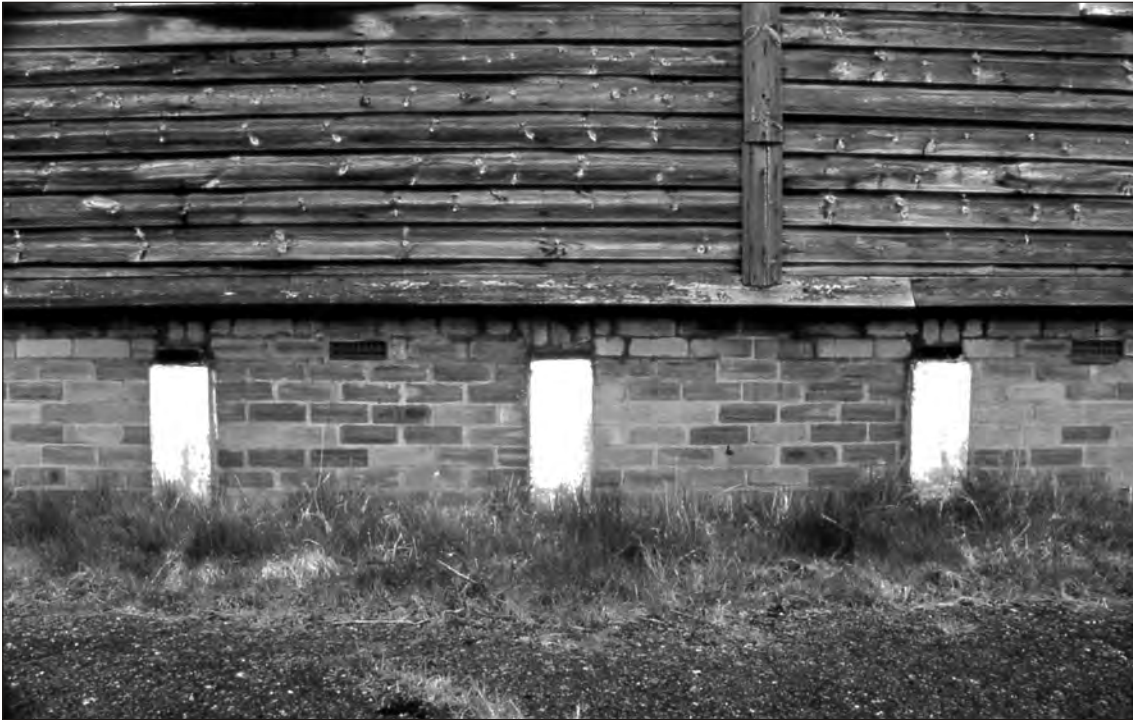
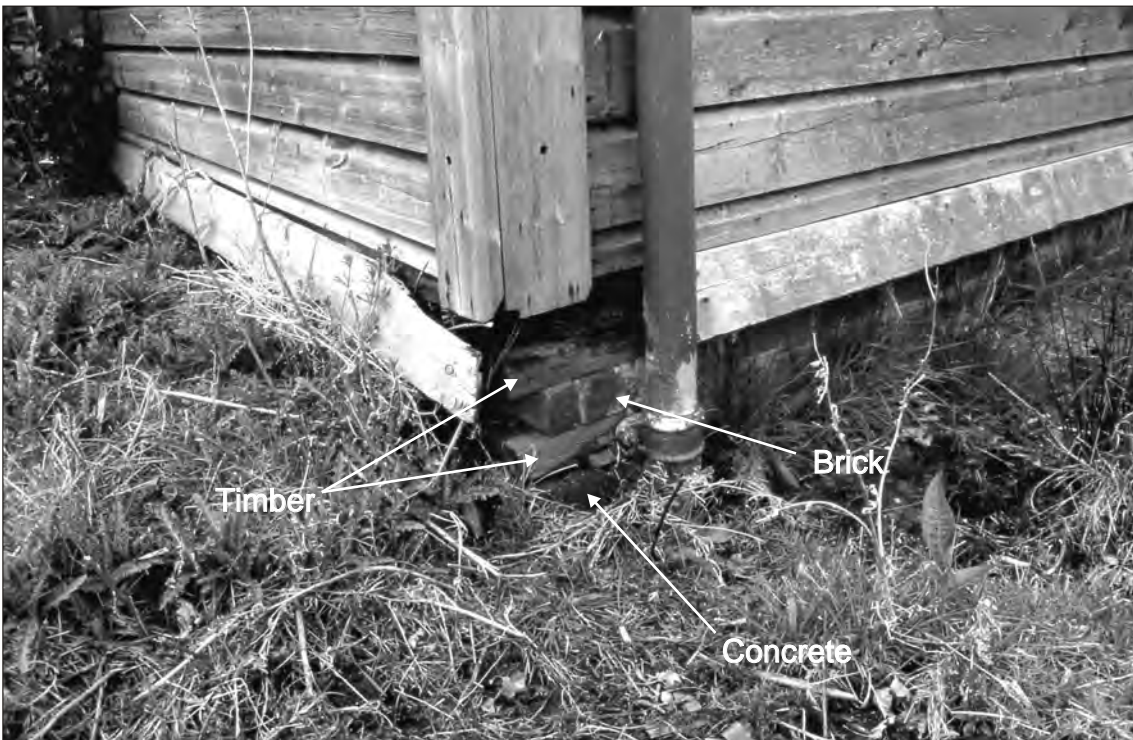
Plate 43 Saighton Camp, Chester: concrete foundation pillars in spider block 22 (also evident in blocks 21, 23 + 39); showing evidence for spider blocks having been raised off the original concrete foundation pillars.

Plate 44 Saighton Camp, Chester: evidence for spider blocks having been raised off the original concrete foundation pillars
