STANDING BUILDING SURVEY

SAIGHTON CAMP

CHESTER

ARCHAEOLOGICAL STANDING BUILDING SURVEY

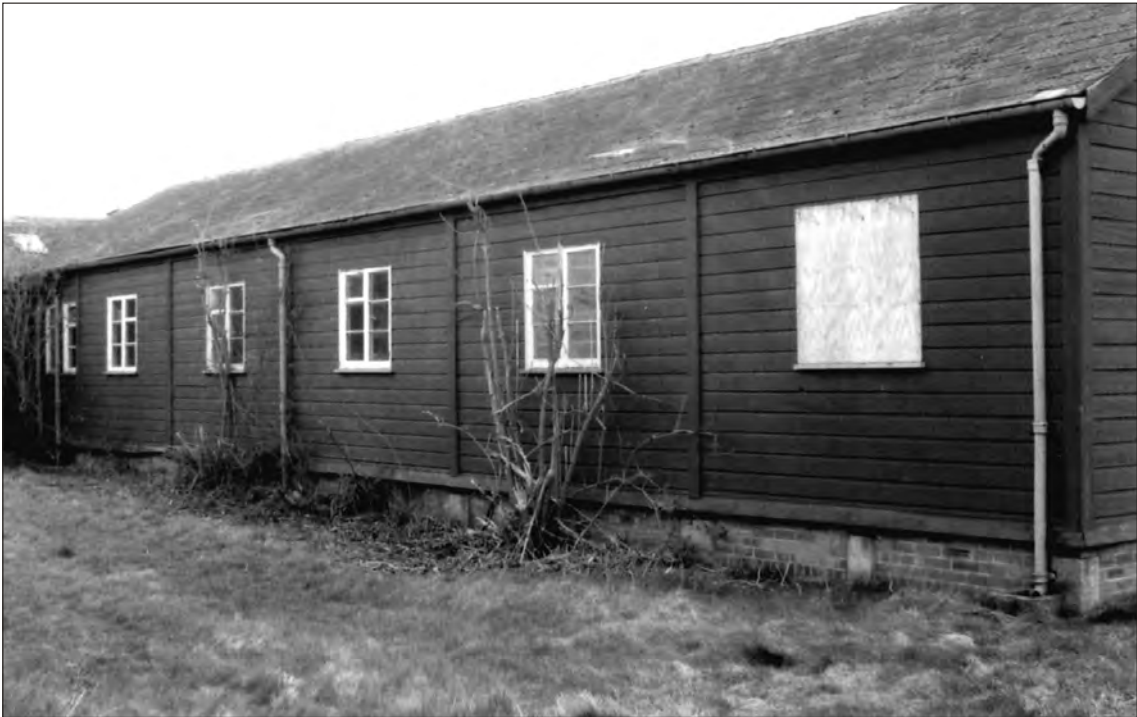
Plate 41 Saughton Camp, Chester: oblique shot of east facing elevation of north-western 'leg' of building 39

- 5.167 The fenestration of the legs of the building was largely uniform with one six-pane casement window in each bay (Plate 41). The exceptions to this included the bays of the inner elevations of all of the huts where they joined with the connecting corridors, which contained single three-pane casement windows, and the most northerly bay of the north-western leg where the window aperture had been replaced by the large loading door noted above. The outward facing corridor elevations each contained a single six-pane window, usually with an opposed window on the inward facing elevation. The fenestration of the body of the building was not uniform. The east-facing elevation of the hut contained two equally spaced six-pane casement windows, the west-facing side contained a single three-pane casement window near its southern end. The north-facing elevation at the eastern end of the hut contained four unequally spaced windows, two of which were six-pane, the other two being three-pane. The north-facing elevation at the western end of the hut contained two three-pane windows either side of a double door leading into the boiler room, and a six pane-window to the east of the doorway. The fenestration of the south-facing elevation of the eastern end of the hut was a mirror image of that found on the north elevation, the south-facing elevation on the western end comprised two equally spaced six-pane casement windows. The frames of all of the windows were constructed from timber which was painted white. The glass used in the windows was laminated in order to render it shatterproof.

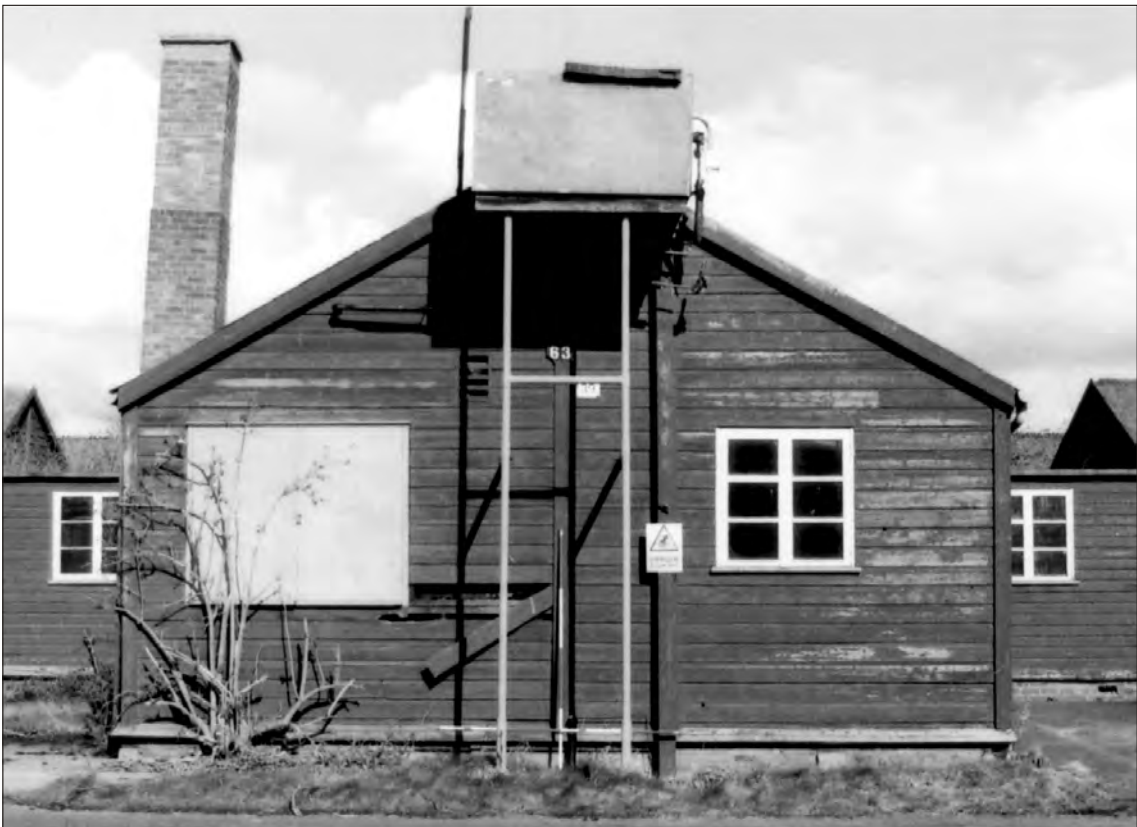
Plate 42 Saughton Camp, Chester: west facing elevation of central sector of building 39

5.169 An iron or steel tower surmounted by a large water tank, was built up against the west facing gable of the body of the building at the same time the boiler room was inserted (Plate 42).

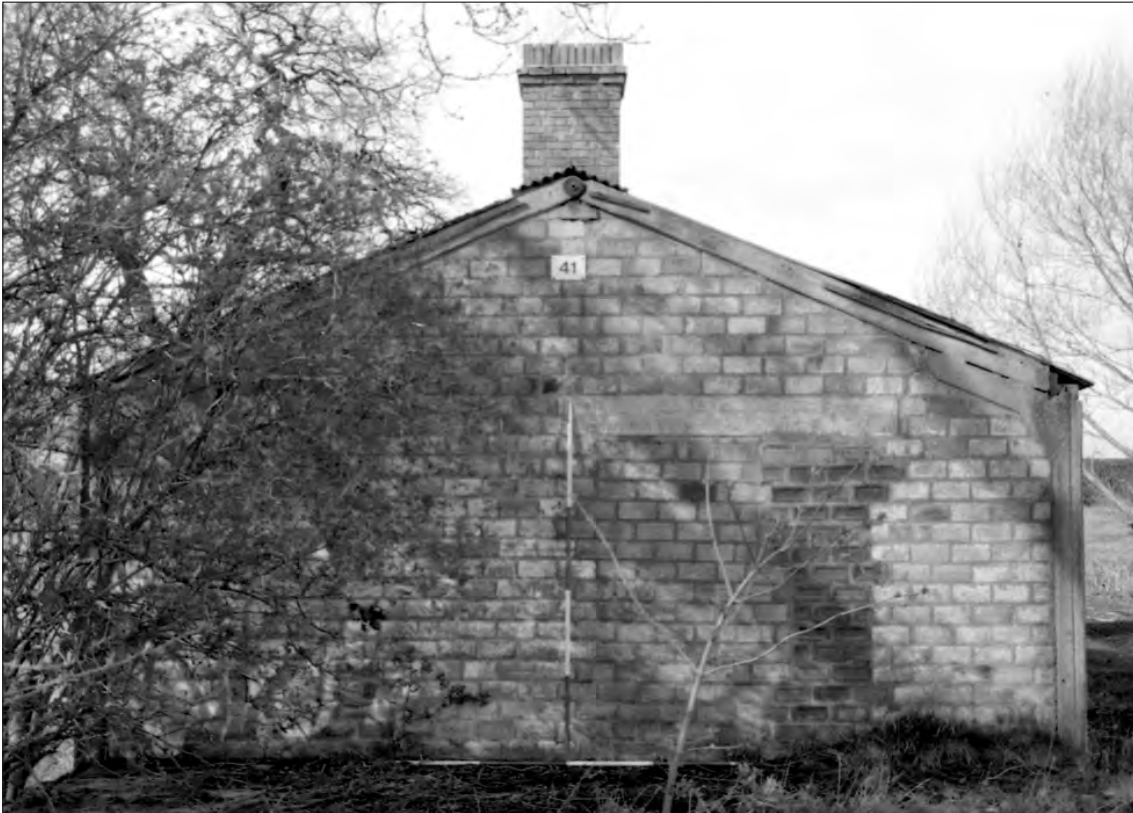
Plate 47 Saighton Camp, Chester: south facing elevation of building 41

- 5.181 The south facing elevation was a gable wall constructed of edge-laid machine made brick in Stretcher bond. There was evidence for a former doorway, surmounted by a concrete lintel in the northern half of the elevation (Plate 47). This had been blocked with machine made brick laid predominantly in an unrecognised bond.

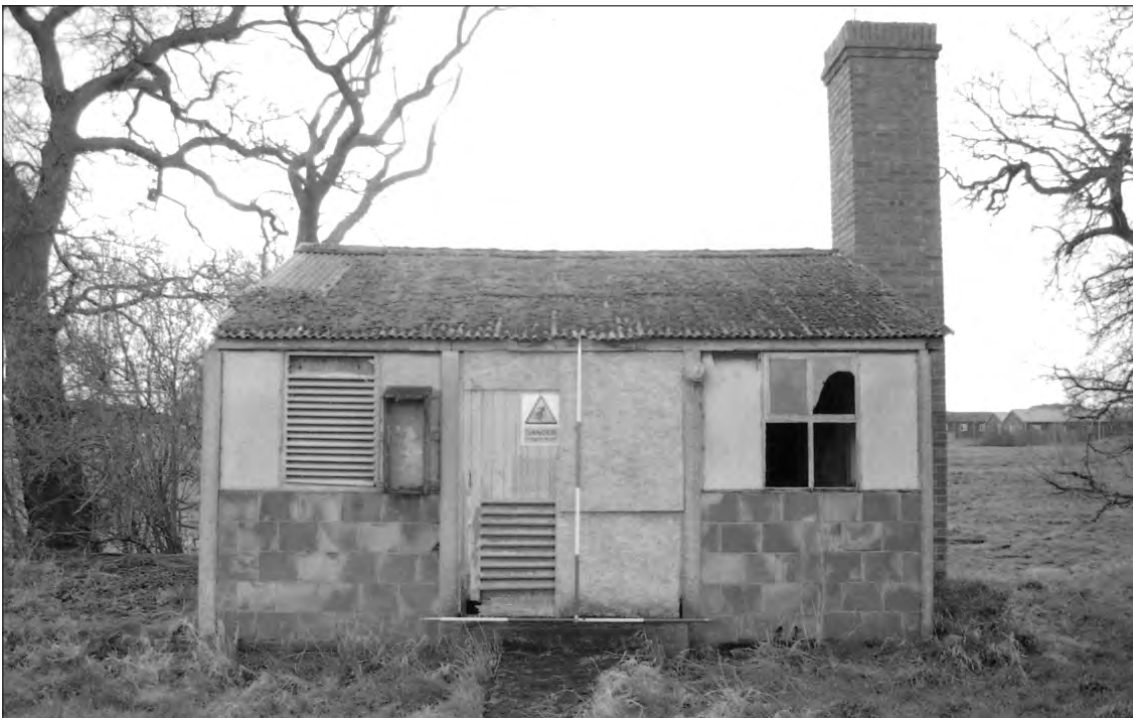
Plate 48 Saighton Camp, Chester: east facing elevation of building 41

- 5.182 The east and west-facing elevations both comprised three bays, each nominally 6'00" wide, separated by two pairs of pre-cast concrete pillars (Plate 48). The pillars were straight and vertical to wall-head level whereupon they curved inwards to act as cantilevers for the concrete rafters of the roof, which were bolted to the post. The north and south bays of the east facing elevation were constructed from edge laid hollow box tiles, measuring 12" x 9", and were 4" thick, to half the total height of the wall. The tiles were mortared in stretcher bond and slotted into vertical rebates in the concrete pillars in order to effect a bond between the two. Two timber-framed windows, each a full bay wide, occupied the space between the walls and the roof line. The southernmost window was covered by a timber-built louver, possibly to provide ventilation once training exercises were over. The central bay of the east-facing elevation was contained a double doorway which occupied the entire bay from ground level to the roof line. This was closed by two timber doors within a timber frame, with timber louvers present on the lower half of each door. A short flight of concrete steps leading to the doorway were placed to its east. A timber box, once containing a fire extinguisher and a siren or other audible warning device, was fixed to the east-facing elevation. The west-facing elevation contained a similar window above a half height wall in its central bay, the other two bays being walled to the roof line.

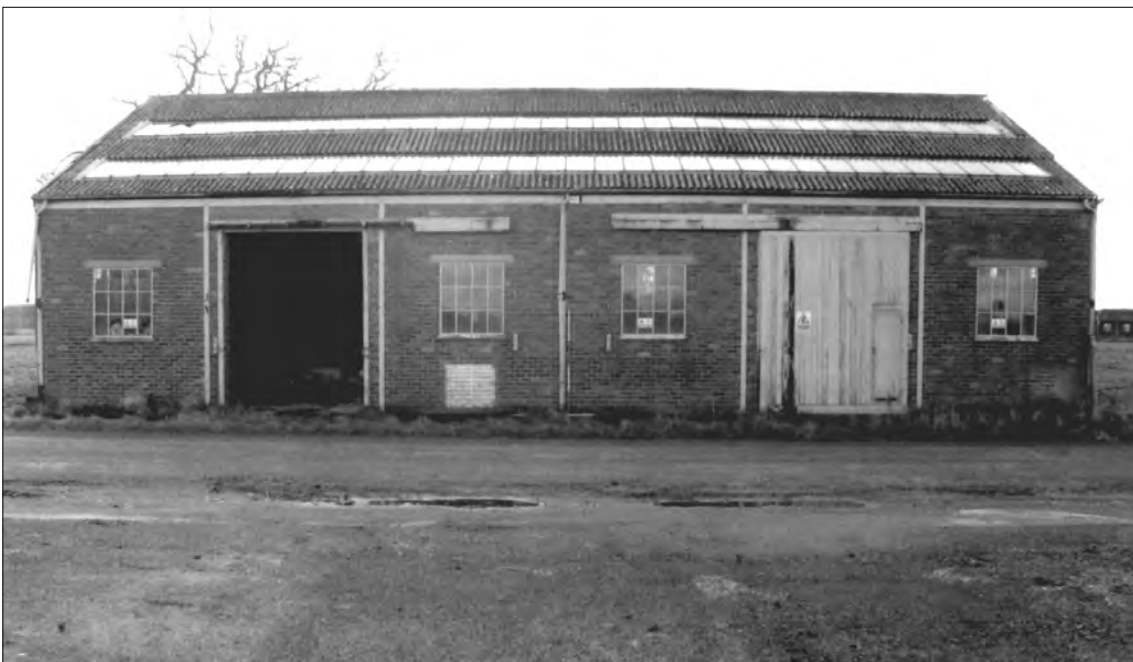
Plate 50 Saighton Camp, Chester: east facing elevation of building 43

- 5.190 The wall fabric of the east facing elevation of the building was composed of machine made brick laid in stretcher bond with concrete lintels surmounting the door and window apertures (Plate 50). The fabric of the southern, western and northern elevations consisted of corrugated asbestos panels suspended from the framework of the building (Plate 51).

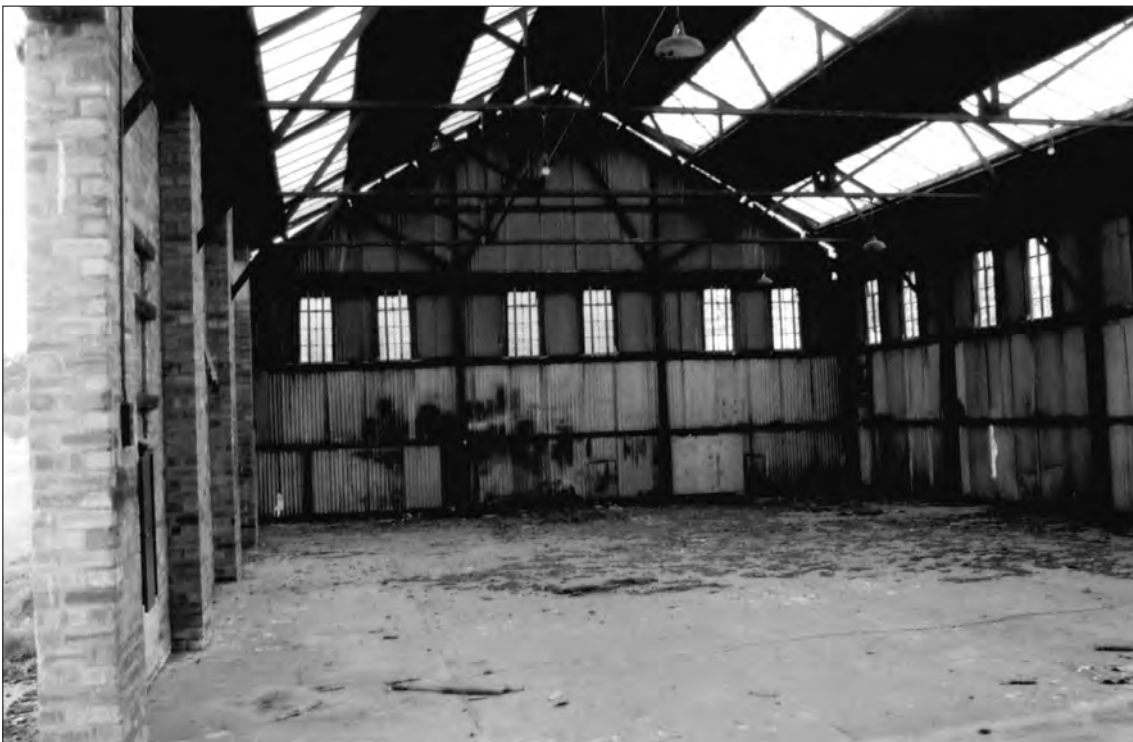
Plate 52 Saighton Camp, Chester: oblique shot of interior of building 42, looking south west

- 5.192 The framework of the building comprised large 'I' section beams set vertically into the floor of the building. The heads of the beams were connected with iron wall plates to create a wall head upon which the roof trusses were set. The vertical components of the framework were further braced by horizontal and diagonal cross-struts from which the corrugated asbestos wall panels were hung. The 'I' beams in the eastern wall were encased in brickwork to their full height. A timber framework for a suspended ceiling was present at wall-head height in Building 43 but not building 42 (Plate 52).

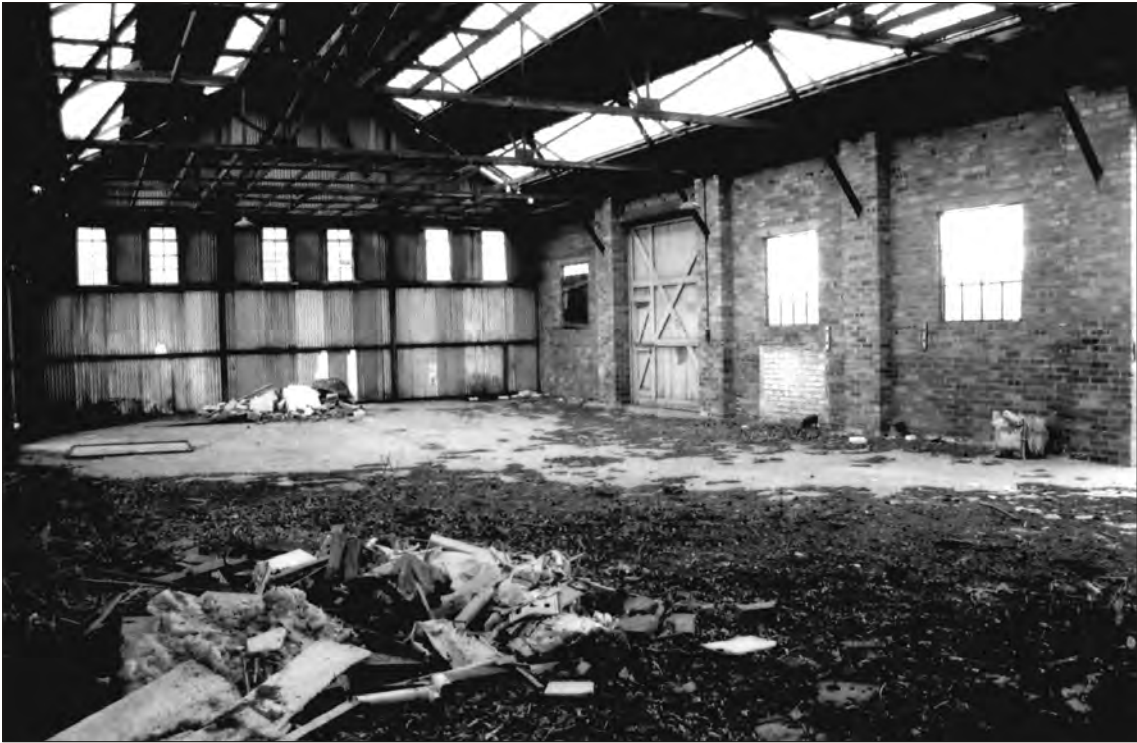
Plate 53 Saighton Camp, Chester: oblique shot of interior of building 43, looking north east

- 5.198 Buildings 42 and 43 are in relatively poor condition (Plate 53). The corrugated asbestos wall and roof panels are damaged or missing in places and many of the windows are cracked, broken or missing. The ironwork of the frames and windows of the buildings is corroding, and the bases of the vertical 'I' beams, which are set directly into the concrete floors, are likely to be rotten, as seen in other buildings constructed in this manner at the camp.
